Memorandum - Enforcement Confidential

Subj: NPDES Compliance Sampling Inspection
Municipal Separate Storm Sewer System (MS4)
City of Chelsea, MA

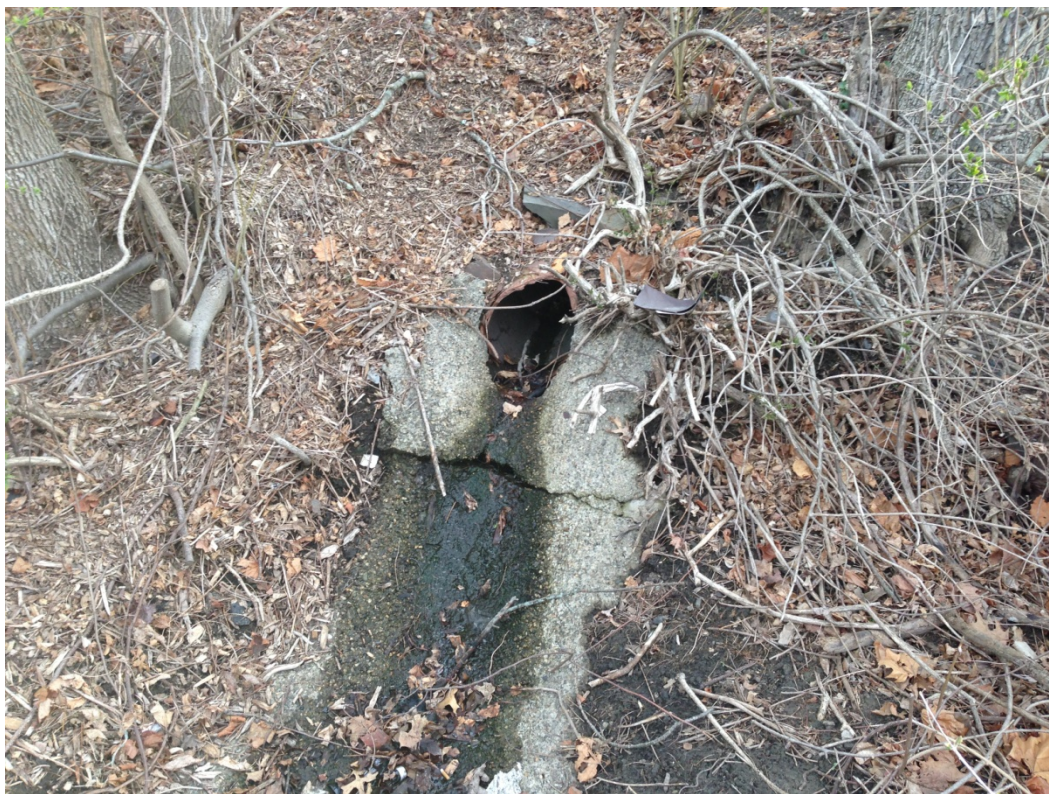
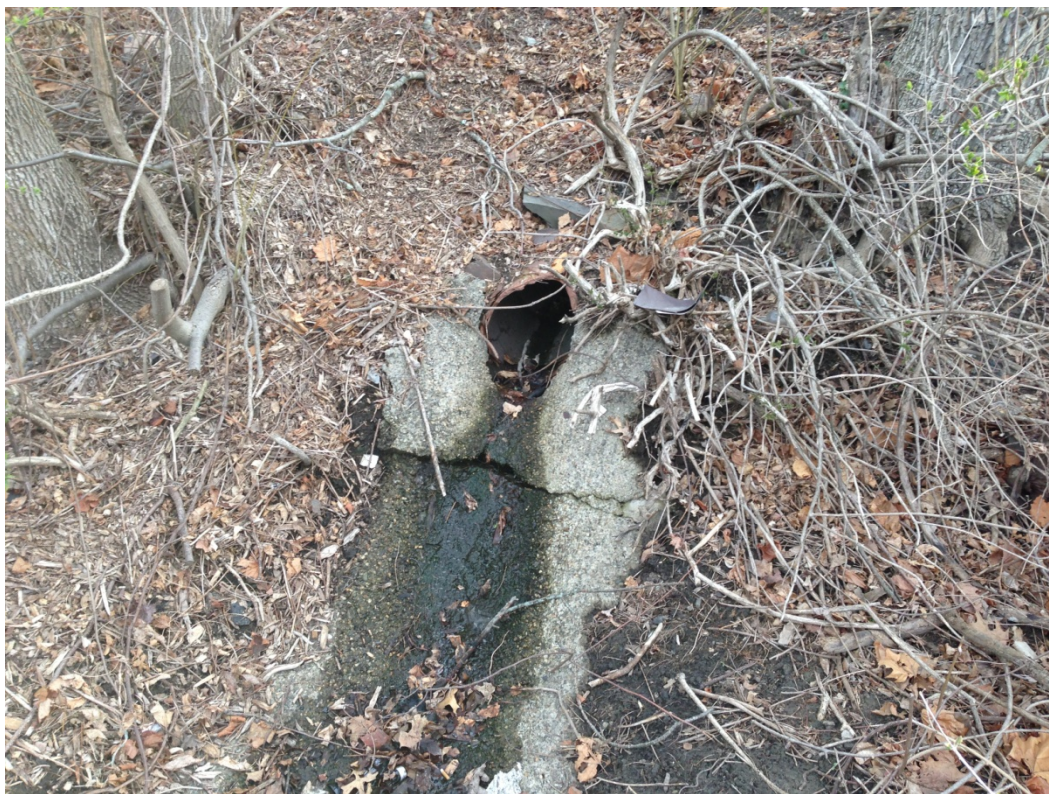
Photo 4: 4/8/13 7:49 am View facing north of storm water outfall on south side of Water Street between Buttonwoods and John Ward Streets. Discharge <0.1 gal/min observed.

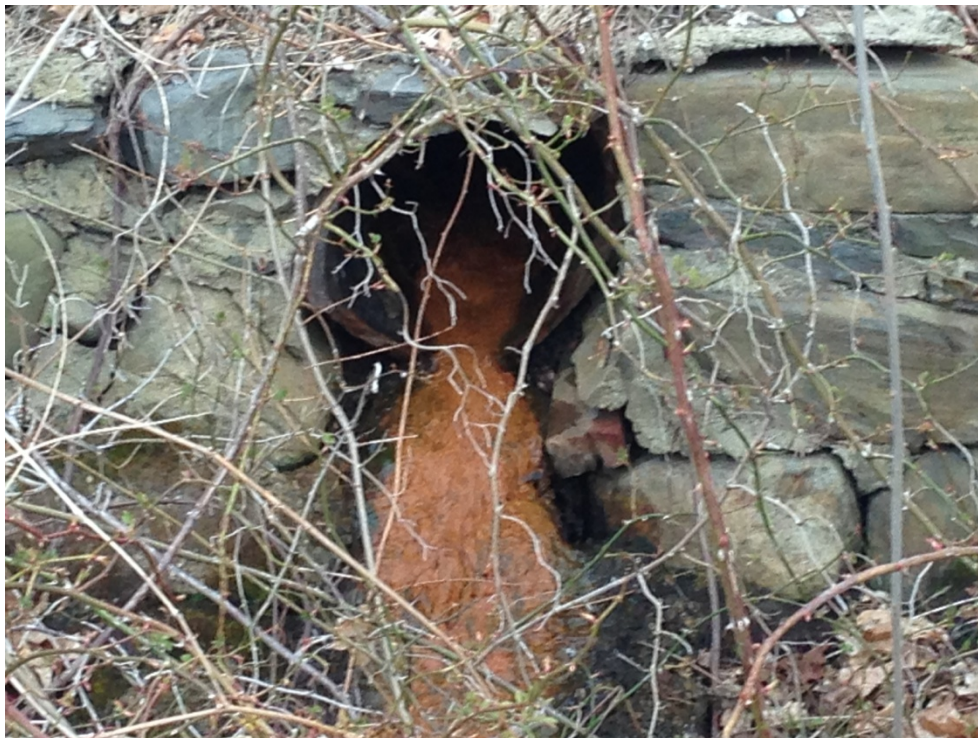
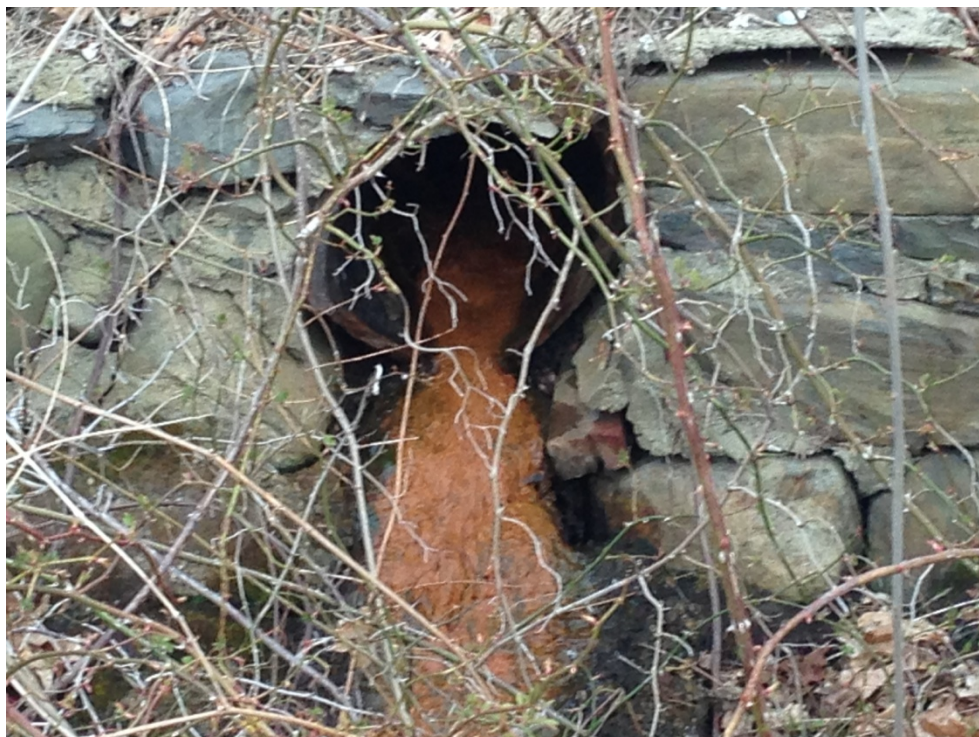
Photo 5: 4/8/13 7:50 am View facing north of storm water outfall on south side of Water Street between Buttonwoods and John Ward Streets. Discharge <0.5 gal/min observed with bacterial growth.

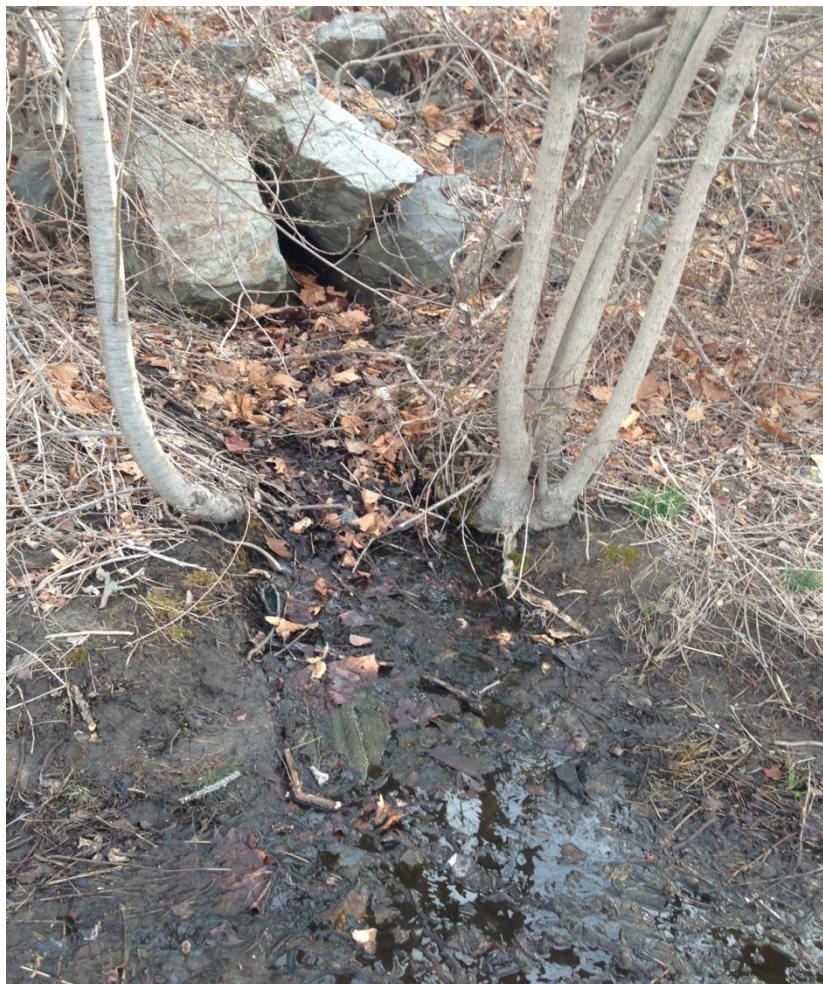
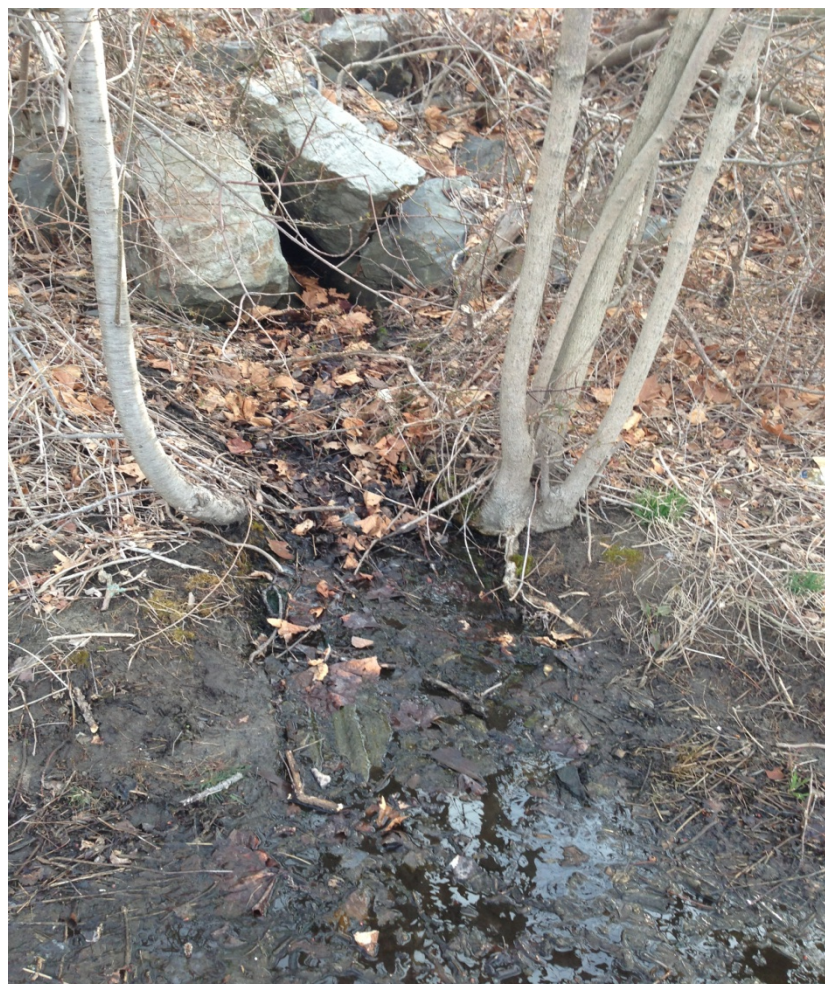
Photo 6: 4/8/13 7:52 am View facing north of storm water outfall on south side of Water Street between Buttonwoods and John Ward Streets. Discharge <0.5 gal/min observed.

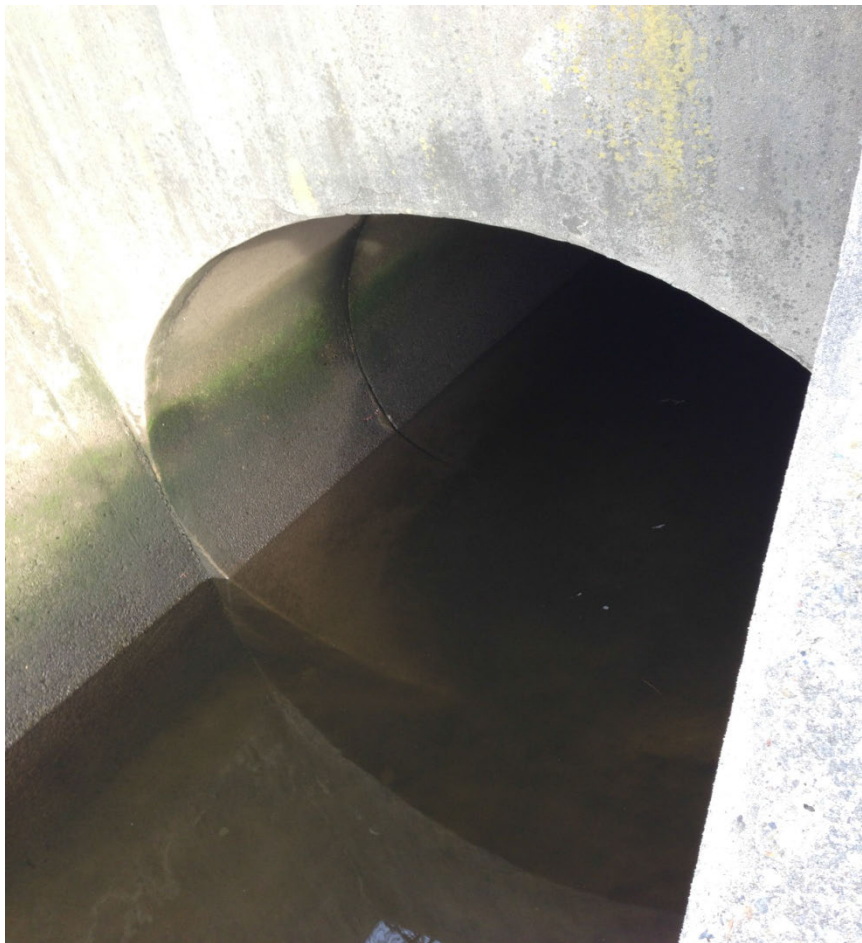
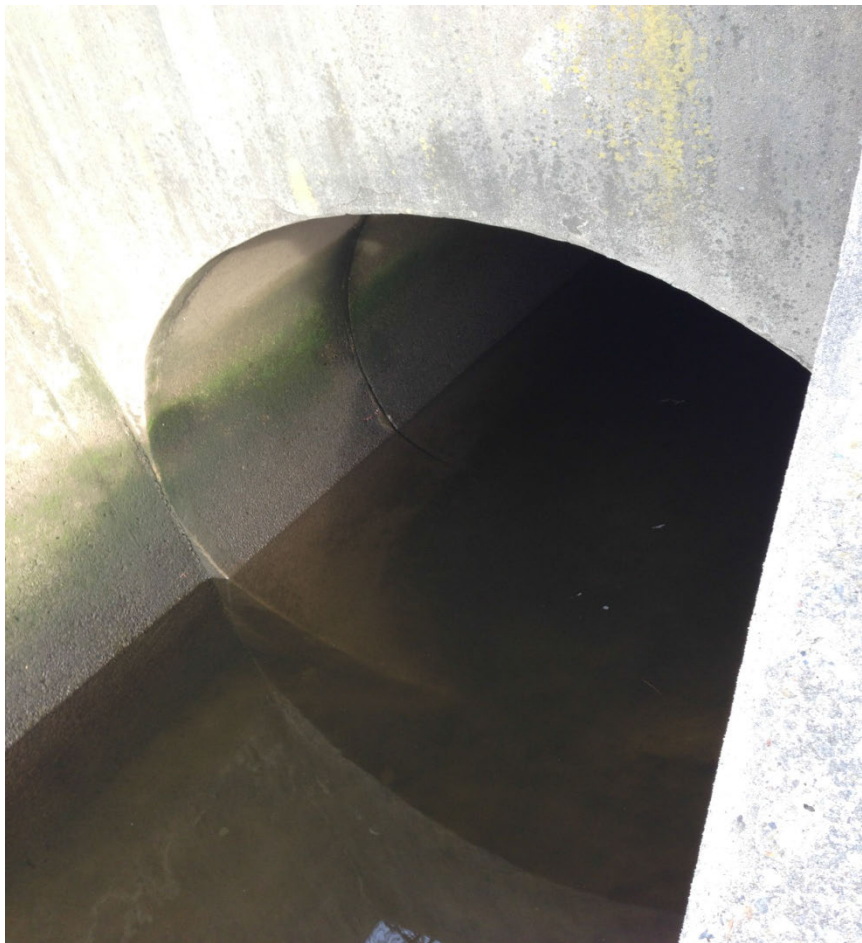
Photo 7: 4/8/13 8:07 am View facing west of CSO #024. Outfall 1/3 submerged – unable to determine if discharging.

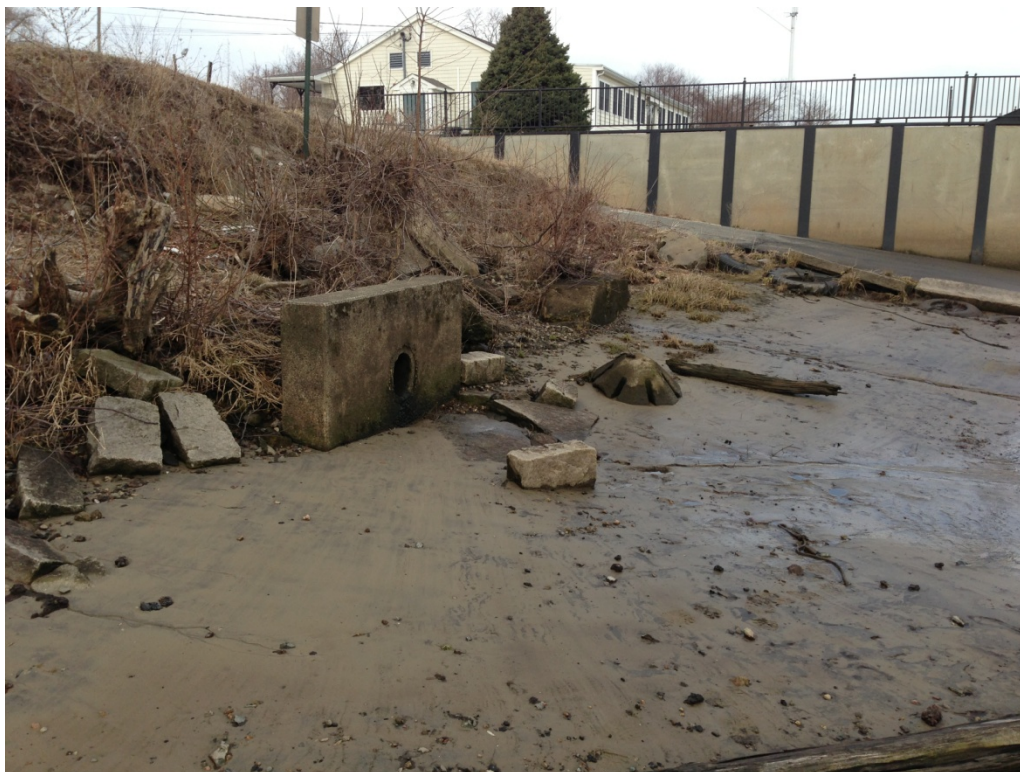
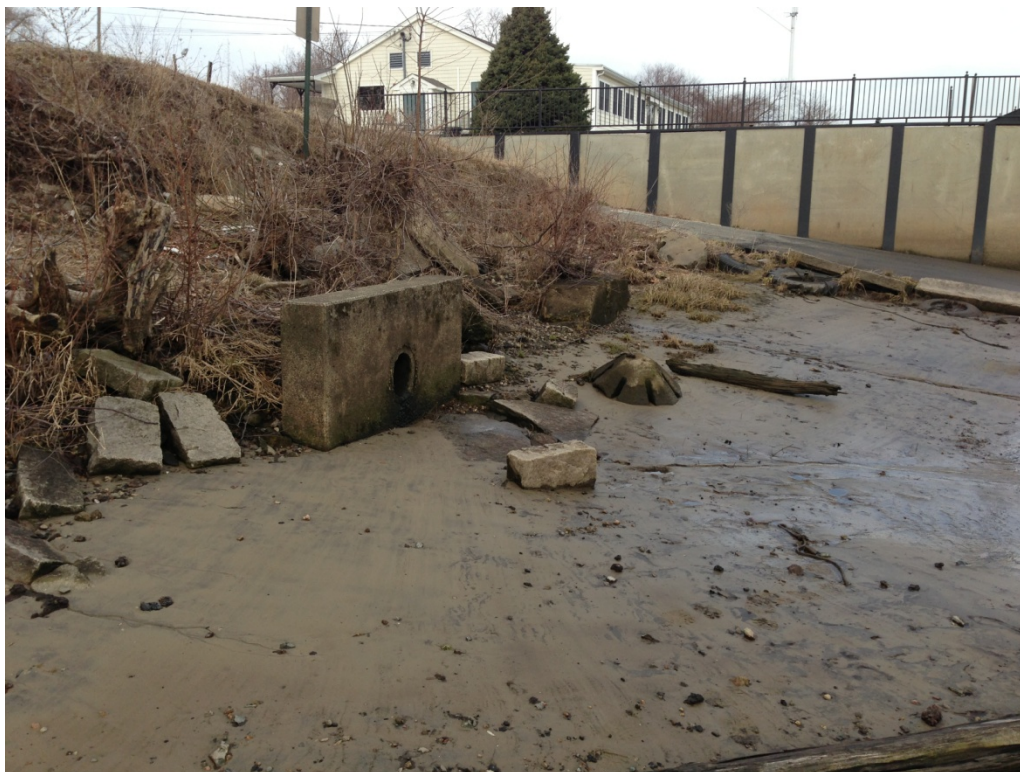
Photo 9: 4/8/13 8:34 am View of CSO #036 No discharge from outfall. Some seepage from hillside behind outfall observed. Located between two boat ramps at Crescent Yacht Club.

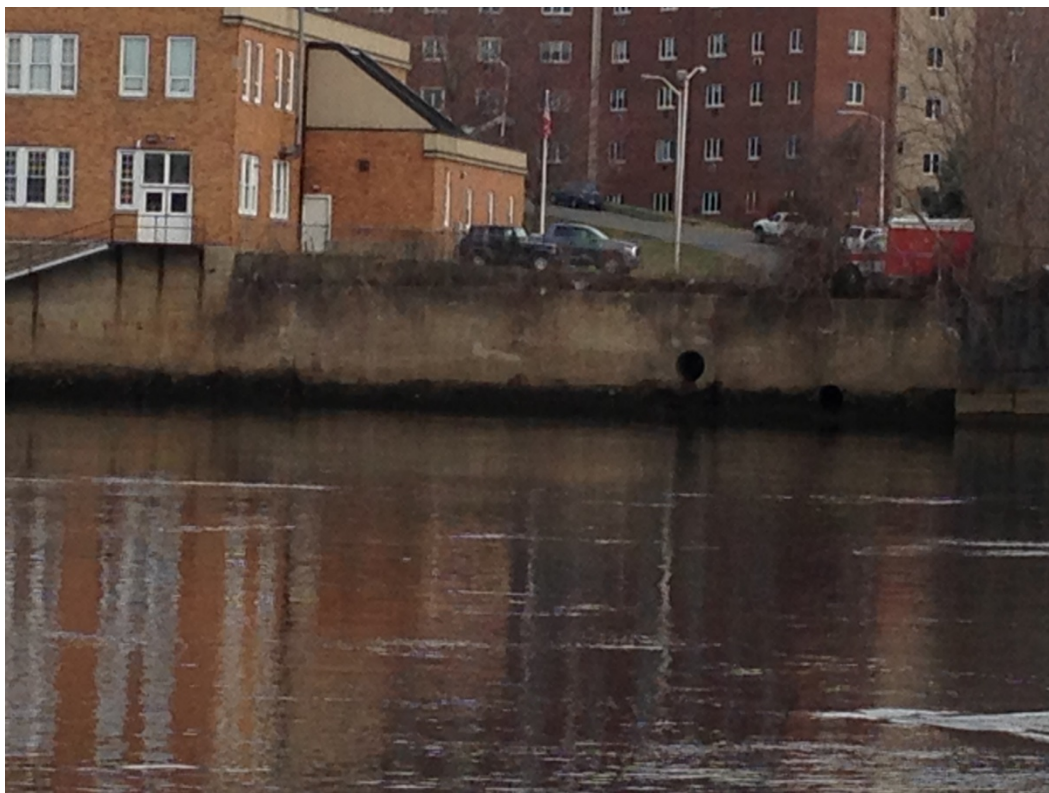
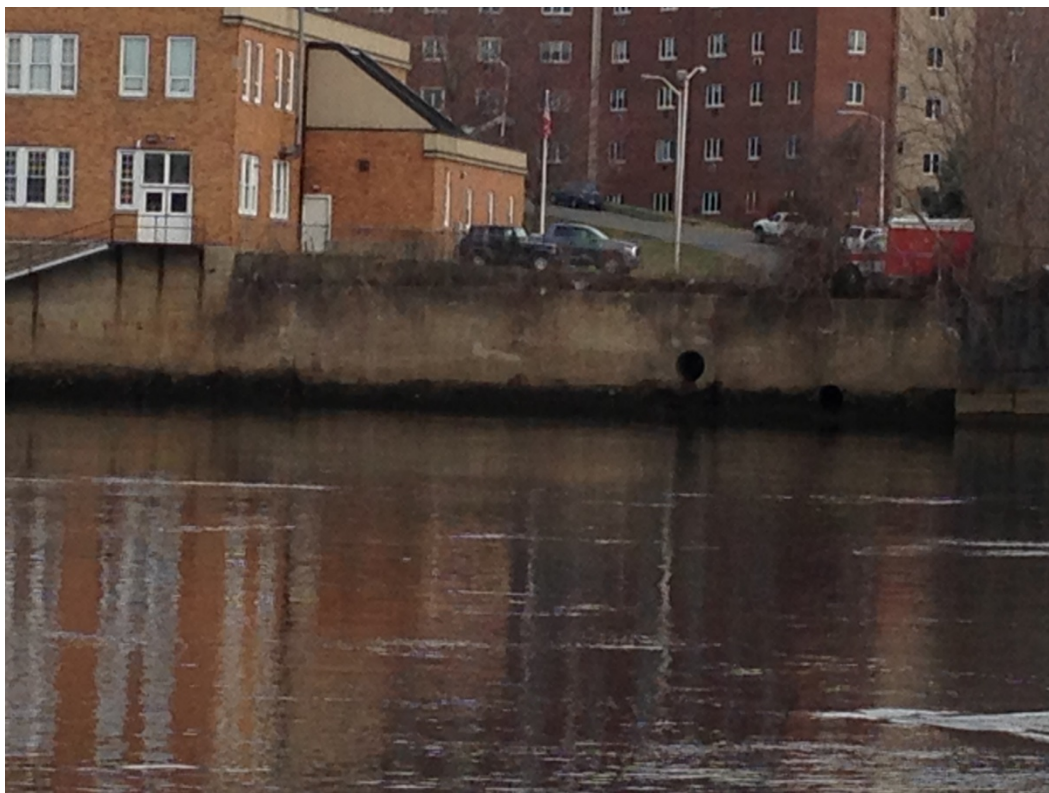
Photo 11: 8:36 am 4/8/13 View facing north from Crescent Yacht Club of storm water outfall MR0608. Unable to determine if flowing at this distance. Water street fire station at left in photo.

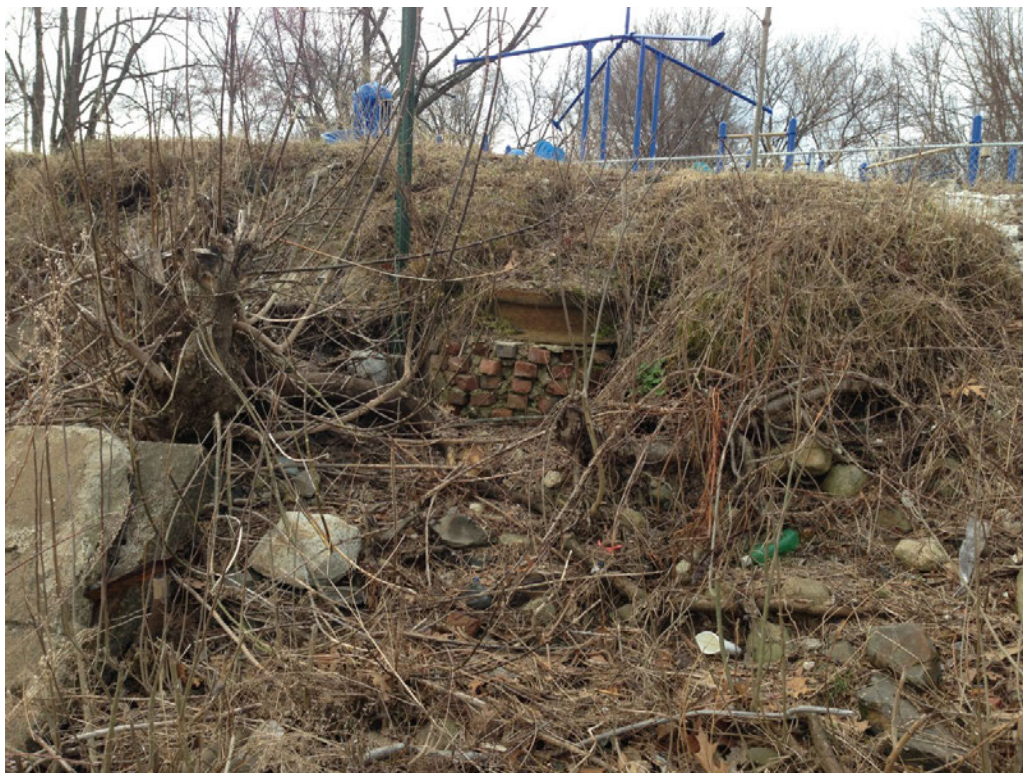
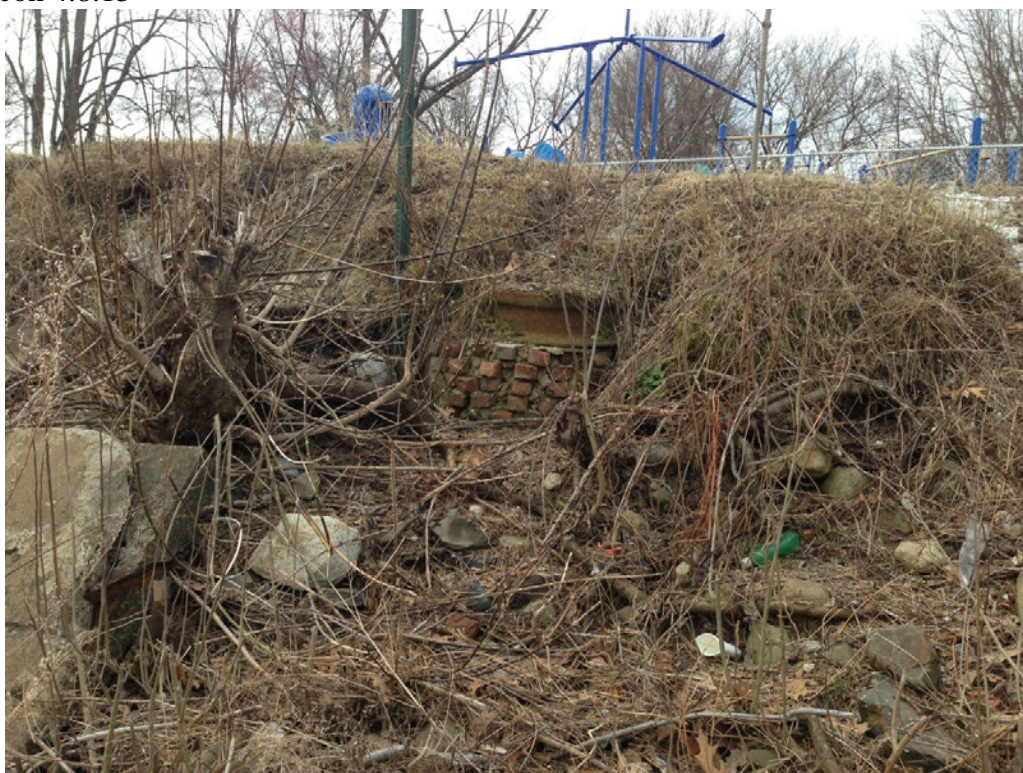
Photo 13: 4/8/13 8:38 am View of sewer manhole structure behind CSO #036. Some seepage was observed from this hillside but unable to determine if discharging from manhole.

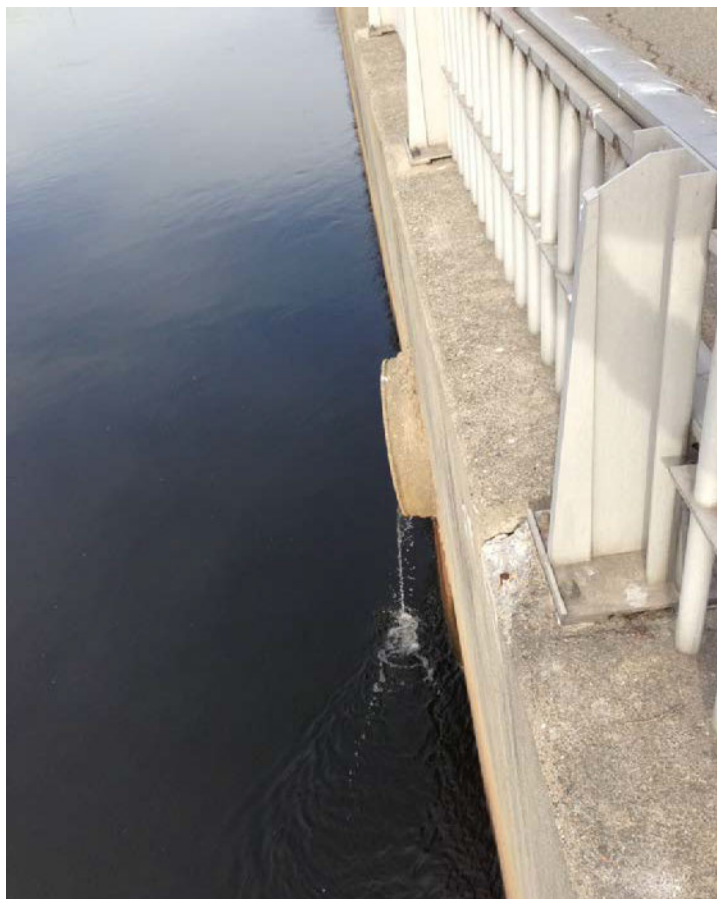
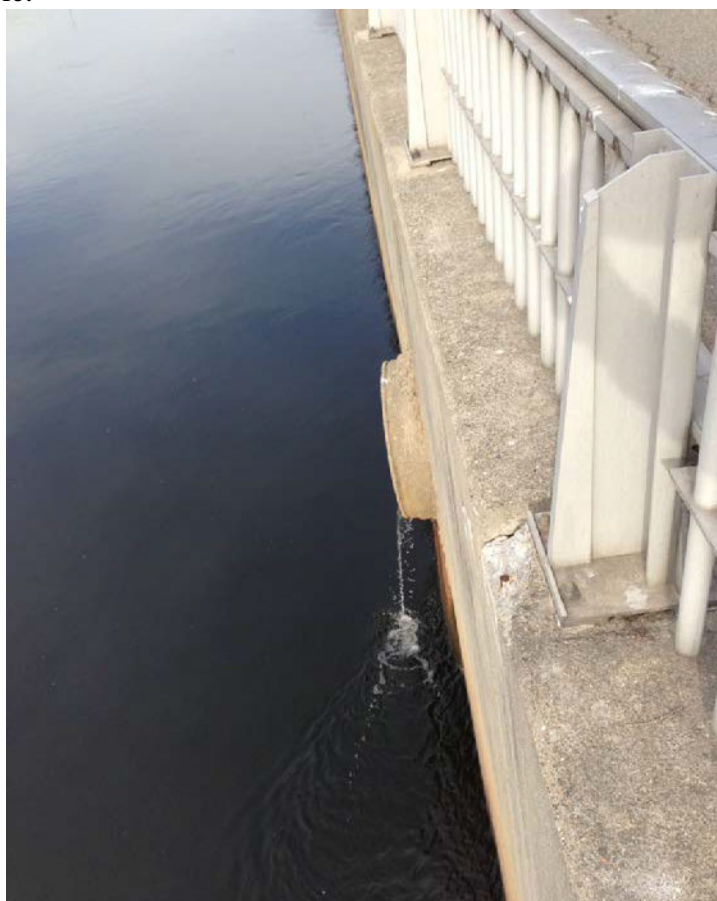
Photo 14: 4/8/13 8:48 am View of stormwater outfall MR 1164. Flow approximately 1 gal/min.

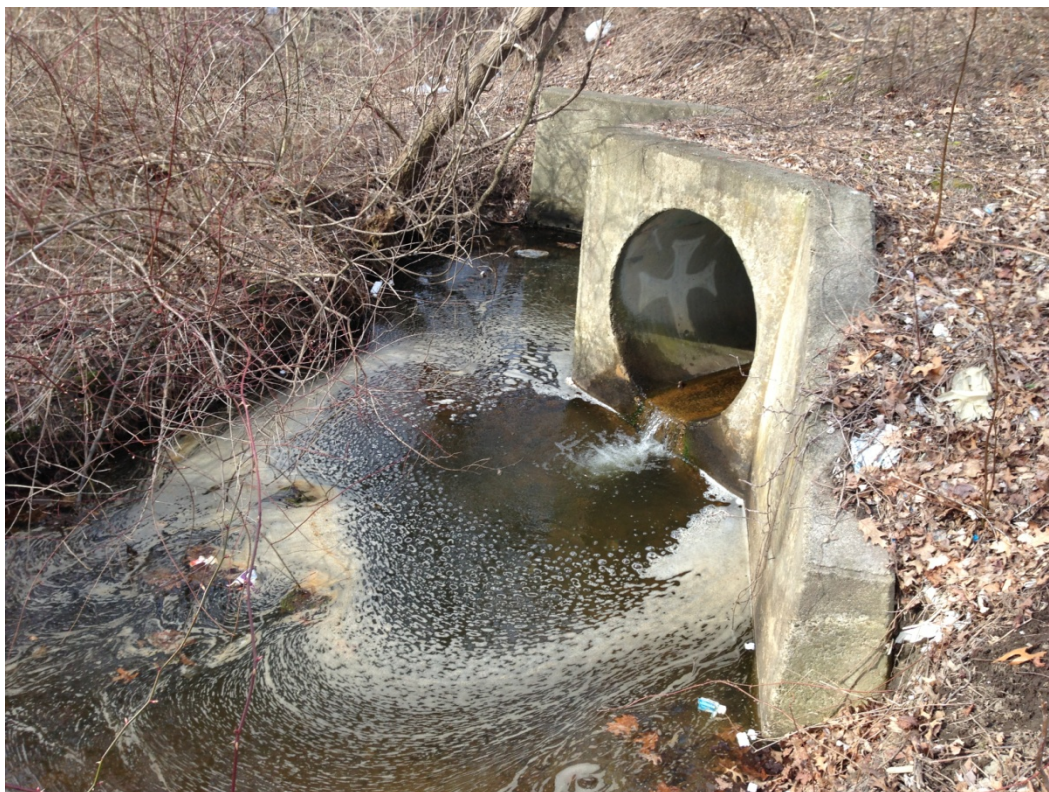
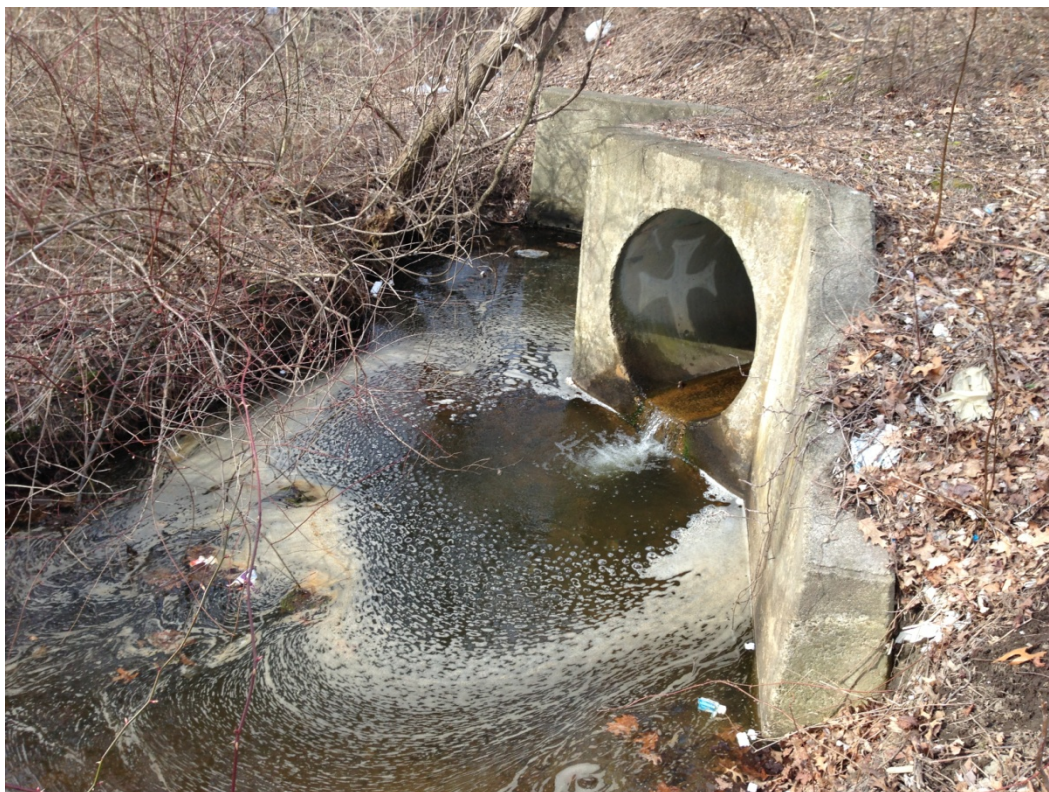
Photo 16: 4/8/13 9:08 am. View facing west of storm water outfall LR 0952 to the Little River, south side of Cashmans Field Playground. Strong chemical/sewage odor, brown foam, and some bacterial growth in pipe. Discharge approximately 5 gal/min.

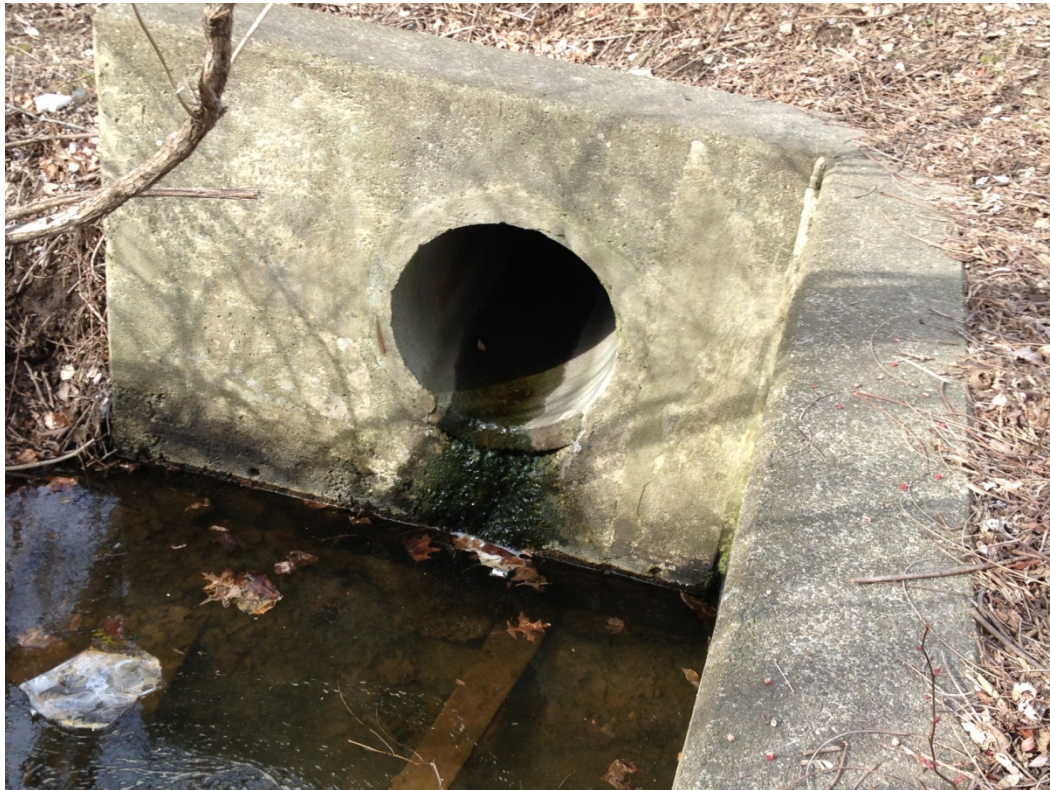
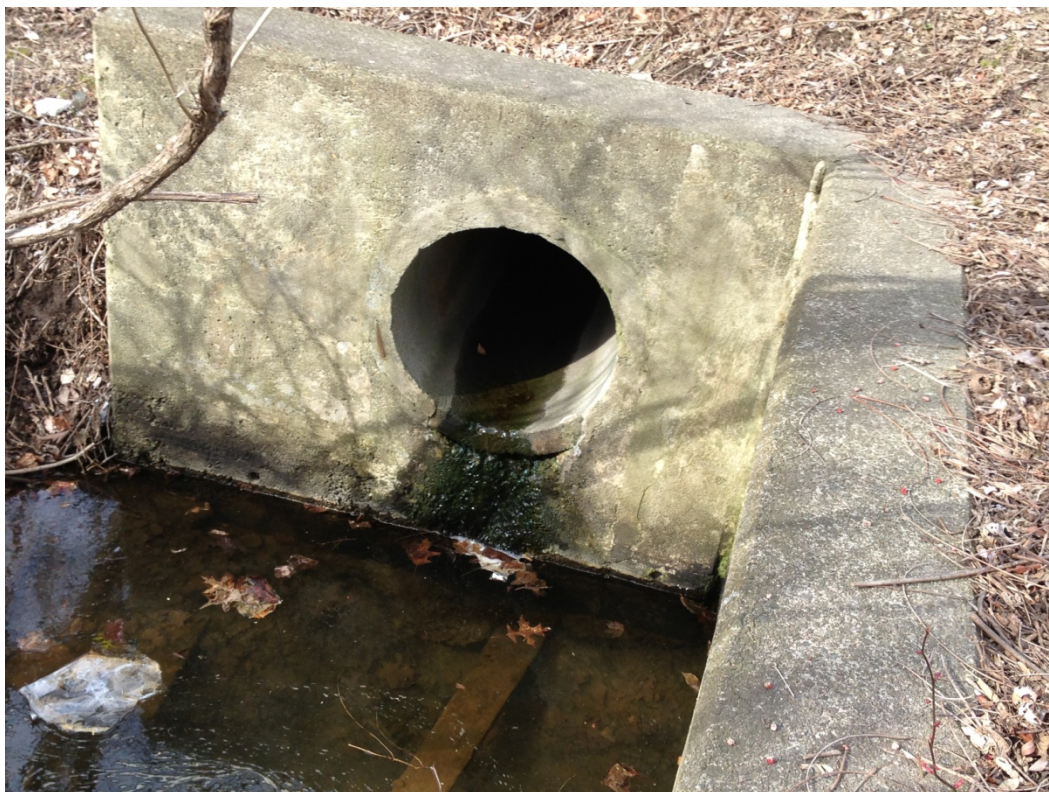
Photo 17: 4/8/13 9:09 am. Photo of unnamed outfall next to (southwest by 10 feet) outfall LR0952. Low flow ($<.5$ gal/min), some algae growth, and some white suds beneath outfall pipe. No obvious odor.

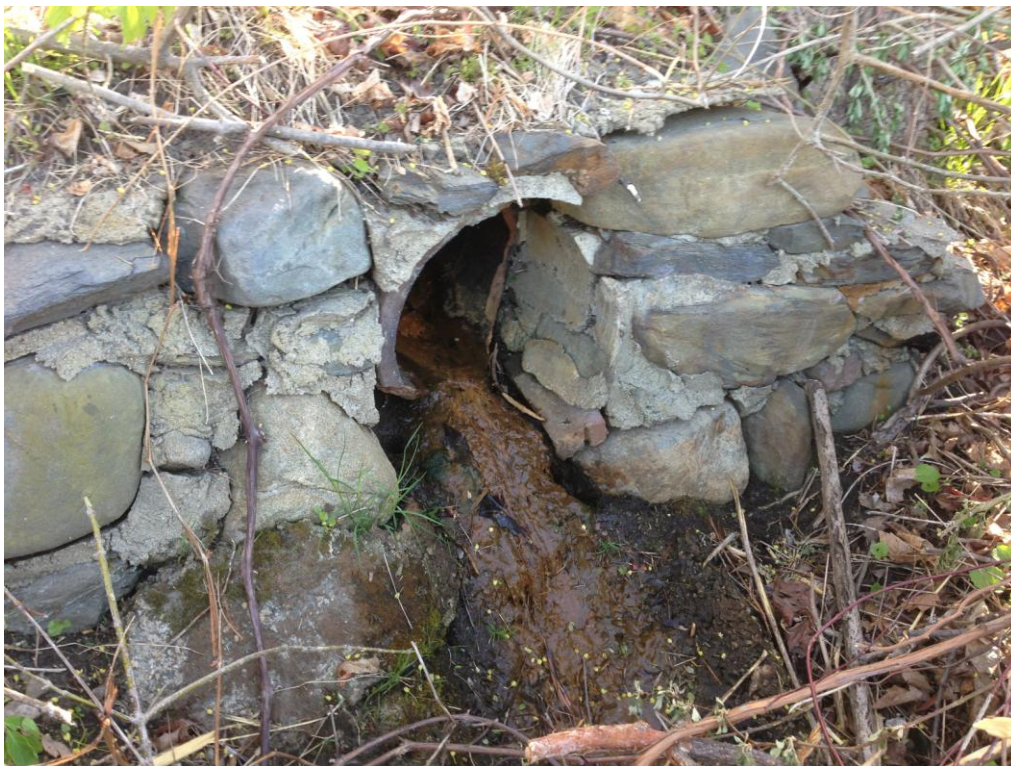
Photo 1: Outfall is location BWOOD1 – note orange staining and bacterial/algae growth.
